Irrigation System Evaluation Report for Conservatory Metropolitan District

September 9, 2013

Keesen Water Management, Inc.
Conservatory Metropolitan District

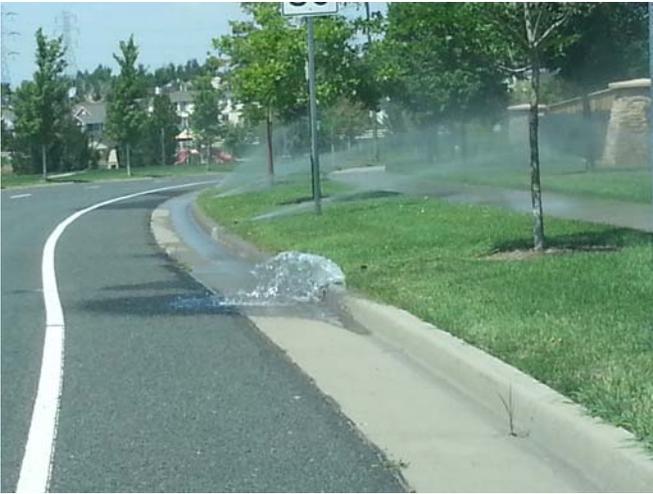
System checks can reduce water loss

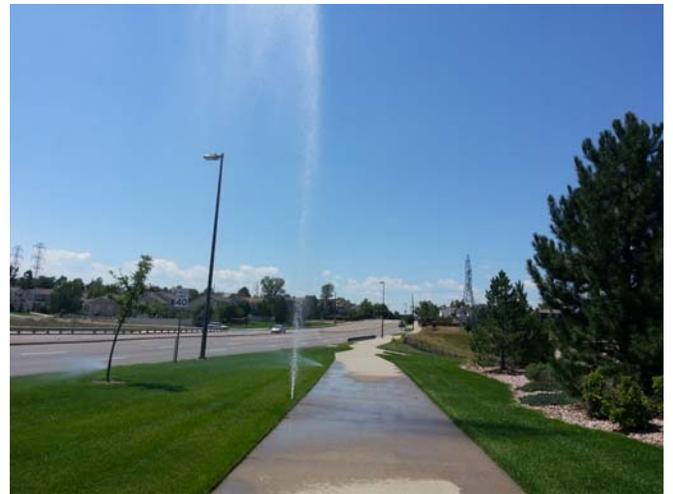
Vandals ???

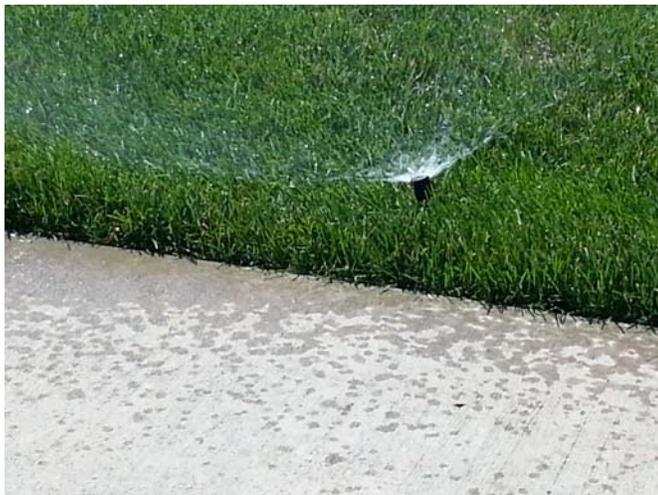
Low head and grass blocking spray

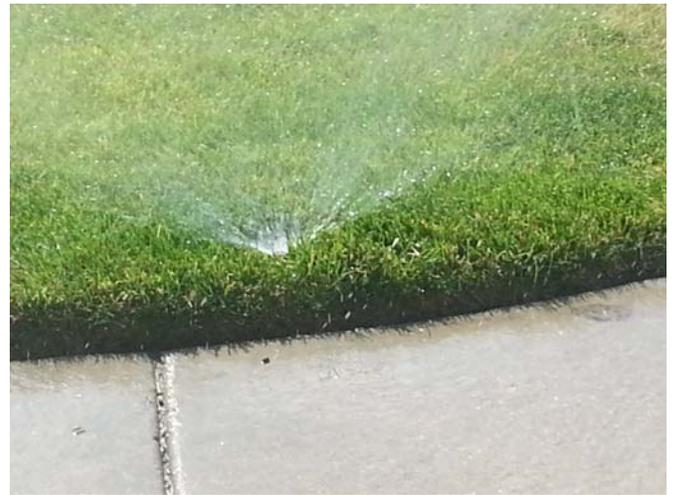
Tilted popup spray head

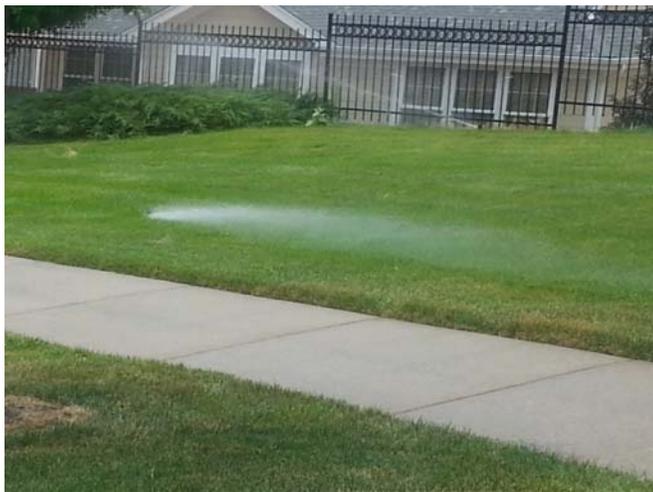
Low rotor head and uneven coverage

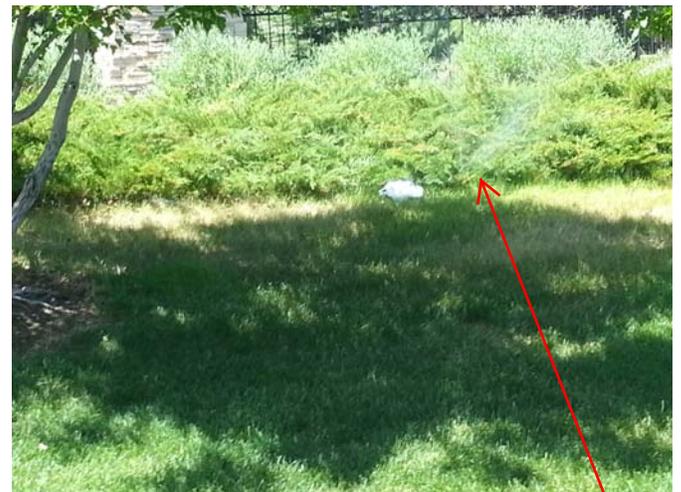
Junipers growing over turf and heads

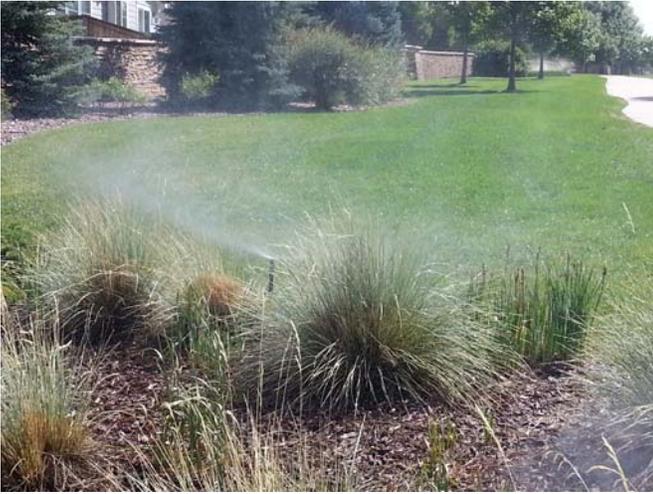
High pressure misting and droplets drifting away

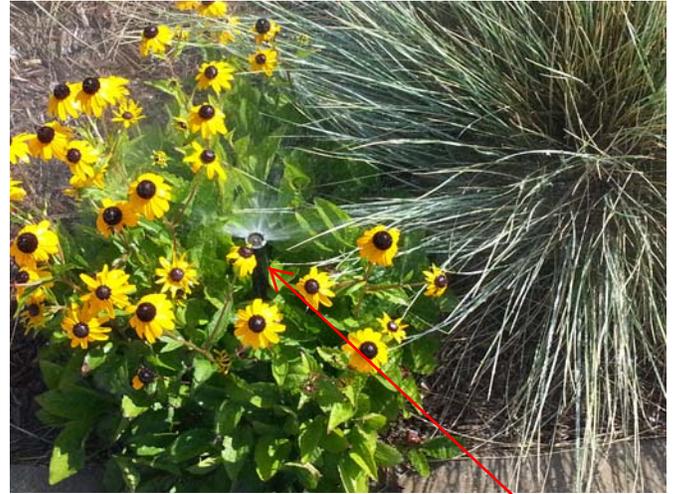
12" popup in the middle of the plant

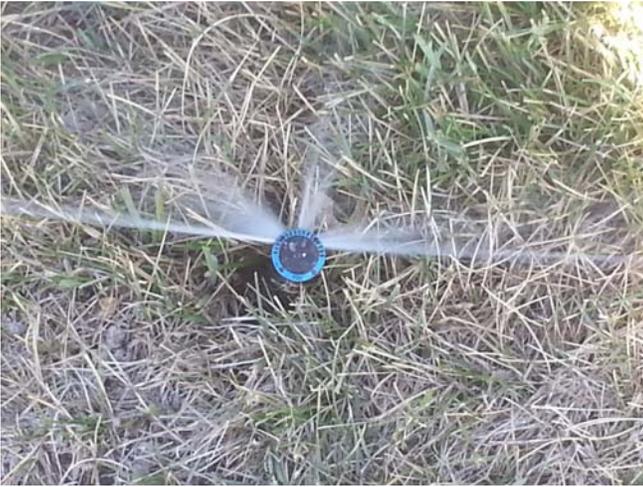
Plugged nozzle on head

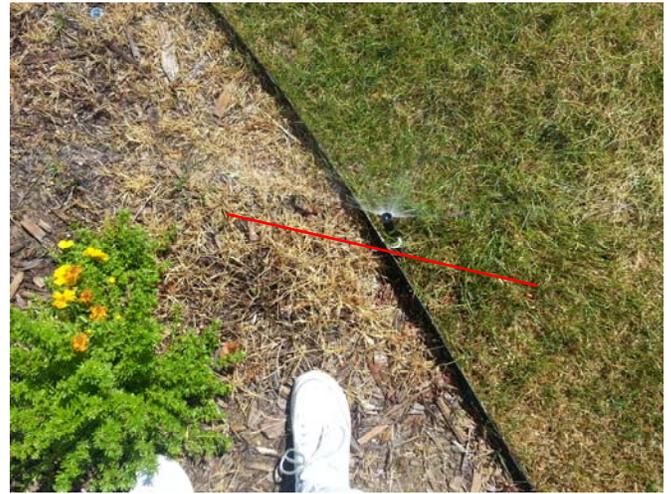
Arc needs adjusting to water turf

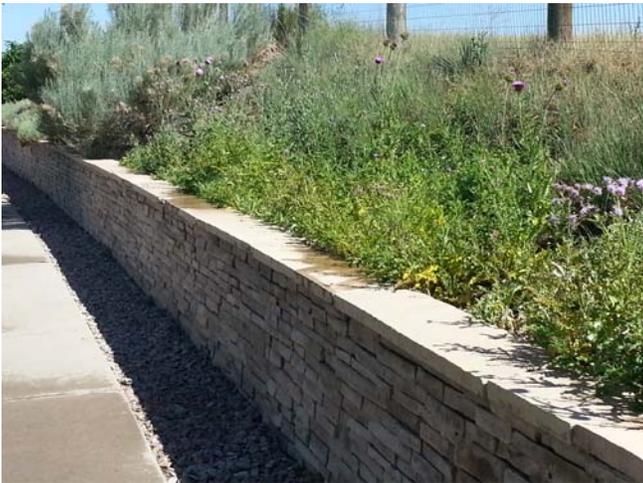
Heads in this planter are smothered in plants

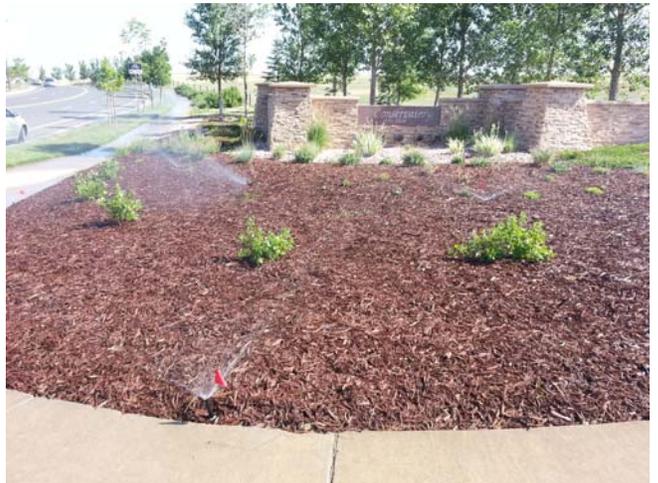
Drip irrigation would save water
