Update "With-Site-Visit" Reserve Study

Conservatory Metropolitan District Aurora, CO

Report #: 36726-0

Date Prepared: October 24, 2019

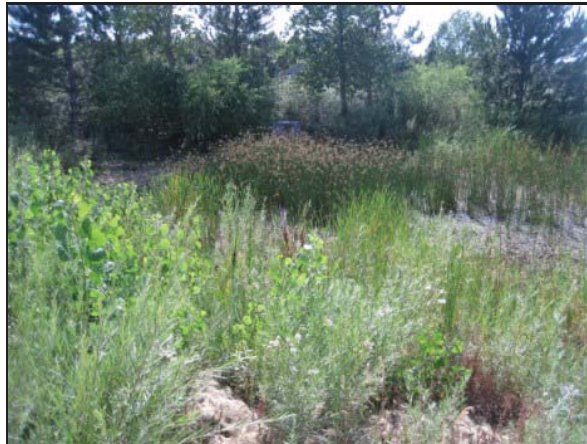
Comp #: 21100 Trickle Channel Pond 6 - Repair**Quantity: System**

Comments: No access to inspect in-ground drainage infrastructure. Annual preventive maintenance work is typically performed as part of a client's general maintenance/operating fund. Under normal circumstances site drainage components are constructed of very durable materials which should have a very long useful life (often assumed to be 50 years or more). Repairs may occasionally be required but timing and scope of work is too unpredictable for Reserve funding in accordance with National Reserve Study Standards. If there are specific known concerns with drainage system we recommend further investigation using cameras or other means to document and identify conditions. Some clients consult with civil and/or geotechnical engineers in order to develop scopes of work for repair/replacement. If more comprehensive analysis becomes available findings should be incorporated into Reserve Study updates as appropriate.

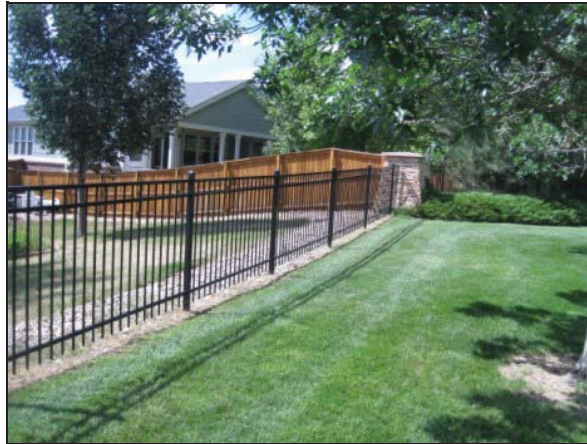
Comp #: 21310 Site Rail: Metal - Replace (Ph 1)**Quantity: ~ 4200 LF**

Comments: Metal railing determined to be in fair condition typically exhibits some minor to moderate amounts of surface wear and other signs of age which may include corrosion loose or unstable pieces/sections or hardware and/or overgrowth by surrounding vegetation. Overall appears to be in serviceable but declining condition. In our experience metal fencing will typically eventually break down due to a combination of sun and weather exposure which is sometimes exacerbated by other factors such as irrigation overspray abuse and lack of preventive maintenance. For some types of fencing complete replacement is advisable over recoating or refinishing due to relatively short lifespan of coatings and consideration of total life-cycle cost.

Useful Life:
30 years

Remaining Life:
24 years

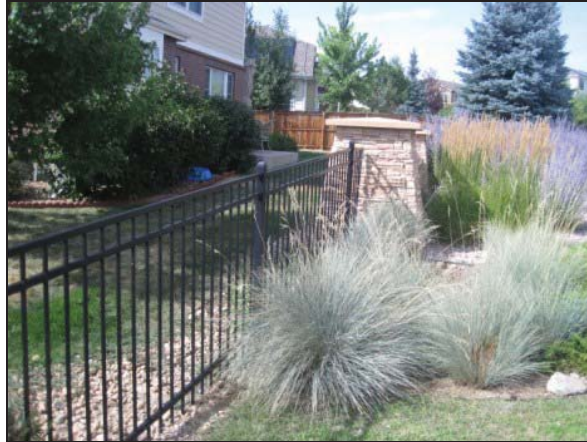
Comp #: 21310 Site Rail: Metal - Replace (Ph 3)**Quantity: ~ 4200 LF**

Comments: Metal railing determined to be in fair condition typically exhibits some minor to moderate amounts of surface wear and other signs of age which may include corrosion loose or unstable pieces/sections or hardware and/or overgrowth by surrounding vegetation. Overall appears to be in serviceable but declining condition. In our experience metal fencing will typically eventually break down due to a combination of sun and weather exposure which is sometimes exacerbated by other factors such as irrigation overspray abuse and lack of preventive maintenance. For some types of fencing complete replacement is advisable over recoating or refinishing due to relatively short lifespan of coatings and consideration of total life-cycle cost.

Useful Life:
30 years

Remaining Life:
26 years

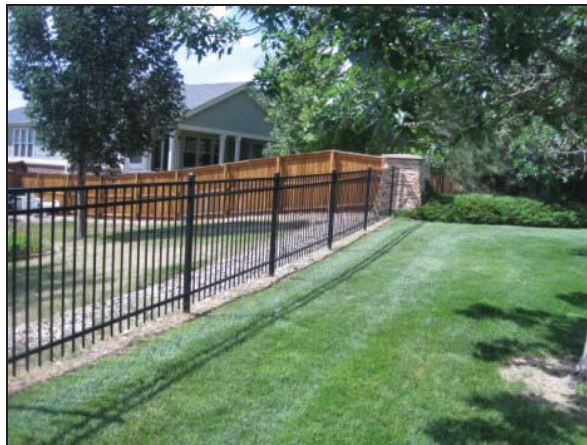
Comp #: 21310 Site Rail: Metal - Replace (Ph 4)**Quantity: ~ 4200 LF**

Comments: Metal railing determined to be in fair condition typically exhibits some minor to moderate amounts of surface wear and other signs of age which may include corrosion loose or unstable pieces/sections or hardware and/or overgrowth by surrounding vegetation. Overall appears to be in serviceable but declining condition. In our experience metal fencing will typically eventually break down due to a combination of sun and weather exposure which is sometimes exacerbated by other factors such as irrigation overspray abuse and lack of preventive maintenance. For some types of fencing complete replacement is advisable over recoating or refinishing due to relatively short lifespan of coatings and consideration of total life-cycle cost.

Useful Life:
30 years

Remaining Life:
27 years

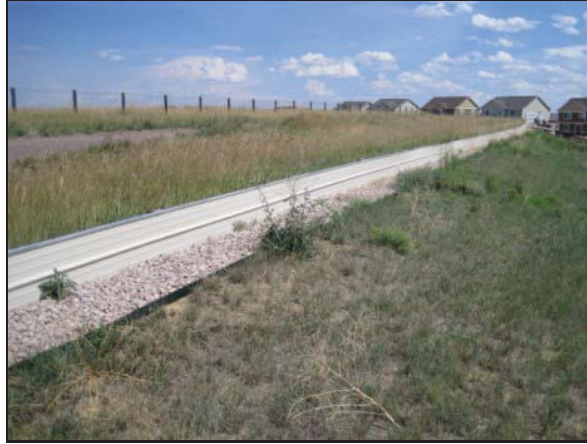
Comp #: 21360 Site Fencing: Prarie Life - Replace**Quantity: ~ 10600 LF**

Comments: Prarie dog fencing determined to be in good condition typically exhibit tights and stable upright posts. Inspect regularly clean and repair locally as needed as part of general maintenance/Operating funds. Assuming ordinary care and maintenance plan to replace this fence as shown below.

Useful Life:
30 years

Remaining Life:
28 years

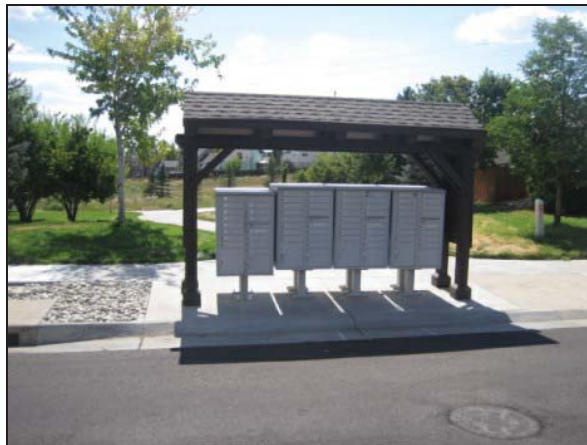
Comp #: 21430 Mail Structures– Repair/Replace**Quantity: ~ (26) Structures**

Comments: Pergola structures determined to be in fair condition typically exhibit more wear and tear possibly including some warped split and/or deteriorated components. Framework/structure should still be sturdy but may have sections showing minor leaning or damage.

Useful Life:
30 yearsRemaining Life:
14 years
